Prepared for: Mr. and Mrs. First Time Home Buyer

Inspection Site: Somewhere in Nassau County, NY

Inspection Date: March xx, 2015

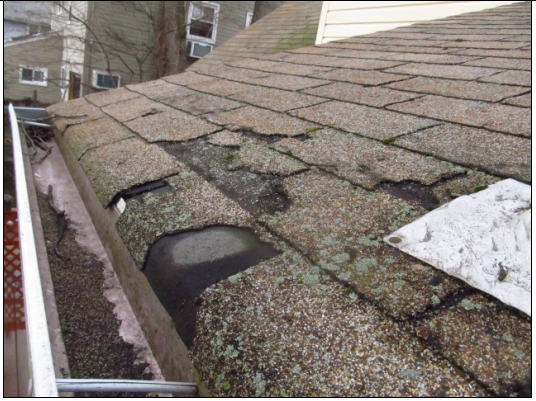
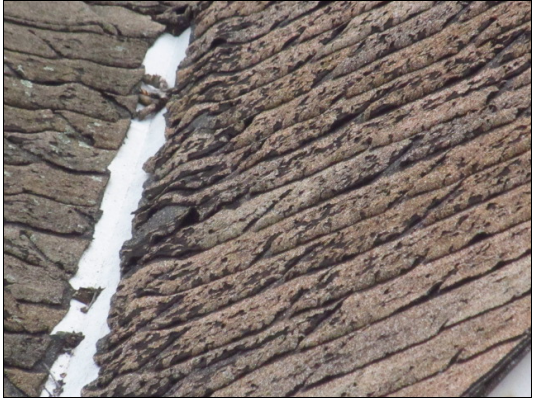
<p>The roof is well beyond its service life. Replacement is needed. Old shingles should be removed first and sheathing checked for damage prior to reroofing.</p>
9. Flashing	Copper	Re-flash entire roof, including chimney, when new roof is installed.

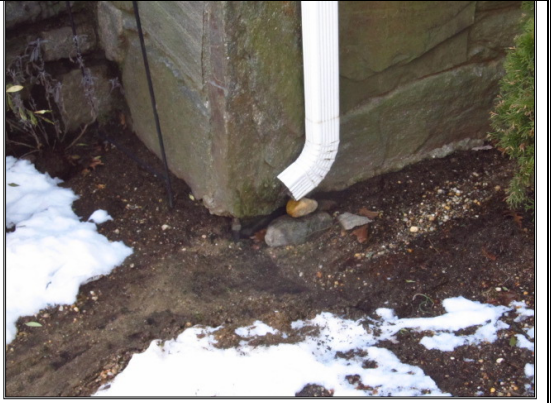
ITEM	MATERIAL	COMMENTS / RECOMMENDATIONS	
10. Gutters/Leaders	Aluminum	<p>Clean gutters upon occupancy. Re pitch gutters and <i>direct downspouts at least 6 feet away from dwelling</i>. Proper management of gutter/leader system is important for preventing soil erosion and possible damage to foundation/structure as well as for helping to keep the basement/crawl area dry. At least twice a year gutters, leaders, and downspouts should be cleaned and checked for proper alignment and connection. As part of normal home ownership, check system during rain for leaks and proper drainage.</p>

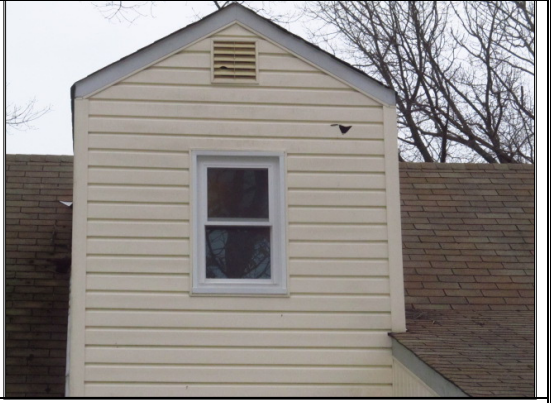
12. Siding	Stone/Vinyl	There is a hole in the rear siding which requires repair to prevent moisture/bird/animal entry.

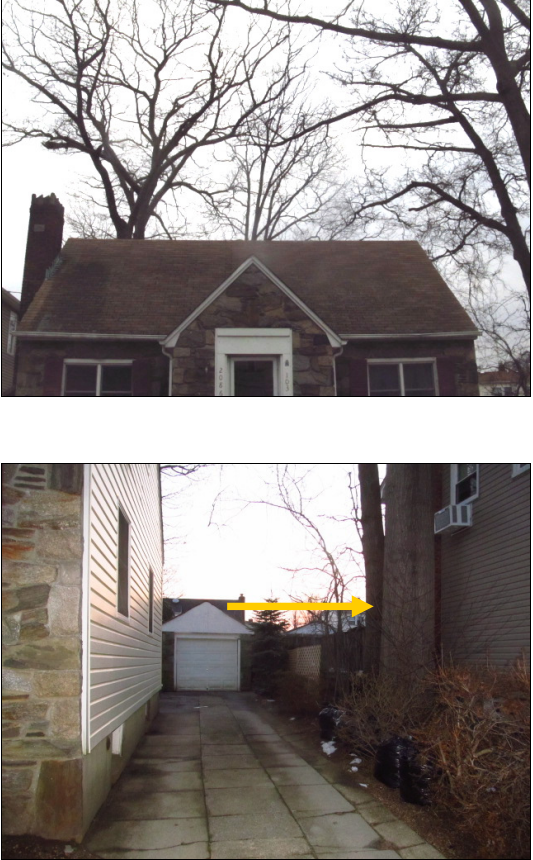
<ol style="list-style-type: none"> 1) Trim trees to allow for proper sunlight penetration onto property and structure. 2) Neighbor's tree roots have damaged the driveway and quite possibly-the foundation. <i>See Comment #36.</i>
26. Patio	N/A	Not Applicable
27. Pool	N/A	Not Applicable
28. Fences	Chain/PVC	Verify ownership of perimeter fencing and maintain where applicable.

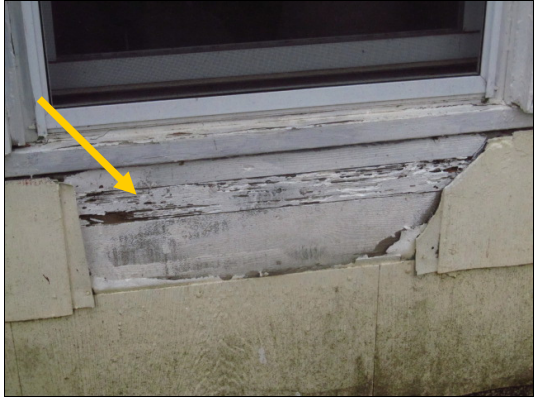
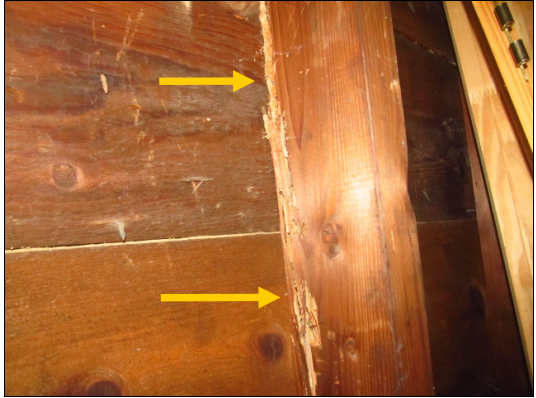
<p>Shown: Termite damage at and adjacent to the left window-inside and out. Also (not shown) the sill plate which attaches the garage to the floor slab is badly damaged. Contact a licensed and qualified general contractor to review/repair/replace damaged framing as needed.</p>

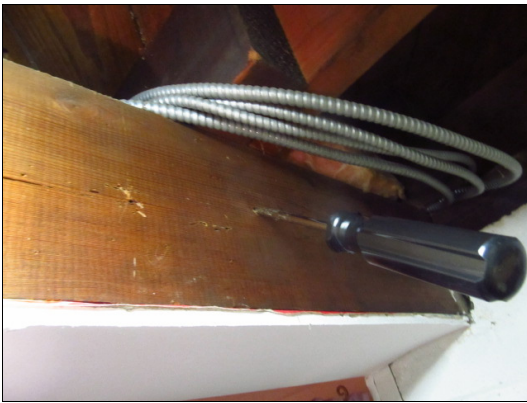
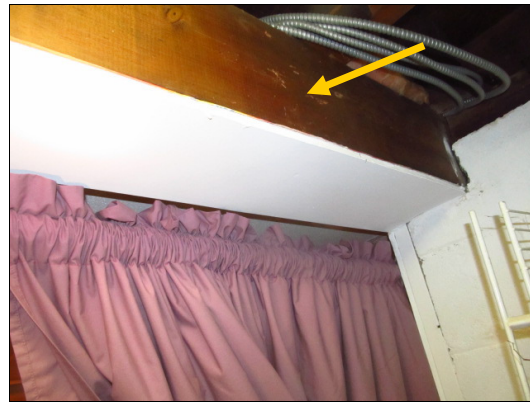
There was termite damage observed at time of inspection. The support beam beneath the front entry is damaged and requires repair. Additional damage may be hidden by finished materials. No indication of a previous treatment was observed; therefore, it will be necessary to exterminate at this time. (Extermination as per chemical manufacturer's recommendations and in accordance with recognized practices and guidelines set forth by the "D.E.C." Department of Environmental Conservation and the "E.P.A." Environmental Protection Agency.) Test borings should be made on all structural members and framing to check for latent damage. Institute repairs as necessary. We cannot represent the absence or presence of termites and other wood destroying insects or resulting damage within closed walls or sealed floors. Contact a qualified contractor to repair or replace all termite damaged wood components in accordance with good building practices.

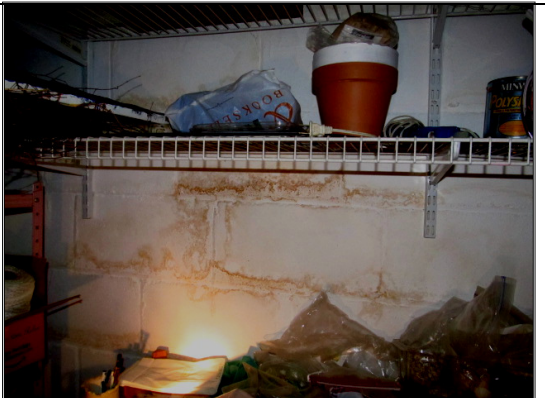
34. Dry Rot	N/A	Not Applicable
35. Water Entry	Evidence	<p><i>Water stains observed on foundation walls. To prevent further water seepage, recommend sealing exposed foundation walls with waterproofing compound and follow Exterior Recommendations 10, 24 to help control water around the foundation.</i></p>

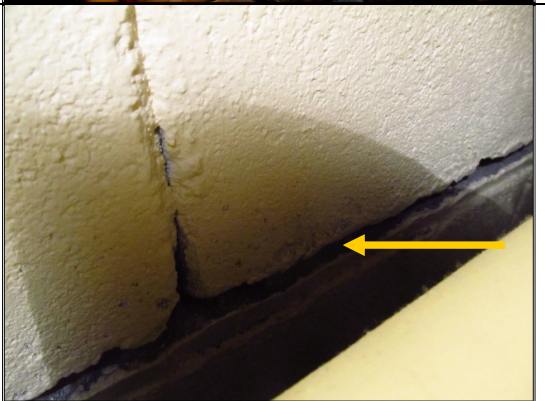
36. Foundation	Concrete Block	<p>There is a large horizontal crack in the driveway side foundation wall. The crack was observed in laundry room and adjacent closet and may continue the entire length of the foundation. A crack of this magnitude is considered a structural failure which will be costly to correct. It is possible that neighboring tree roots are the cause. <i>See Comment #25.</i></p>

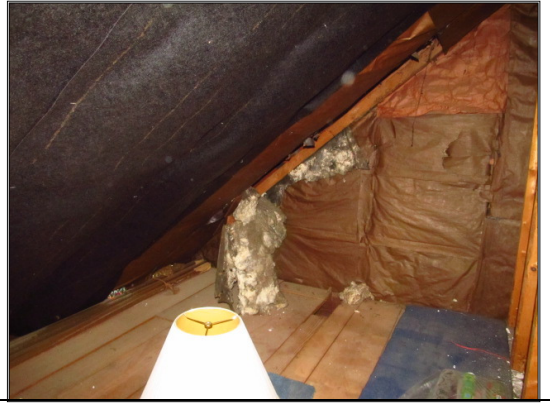
ITEMS	DESCRIPTION	COMMENTS / RECOMMENDATIONS
39. Insulation	Fiberglass	<p>Remove deteriorated insulation from between roof rafters and install new insulation on the back of the knee wall. This will help insulate the second floor while improving roof ventilation.</p>

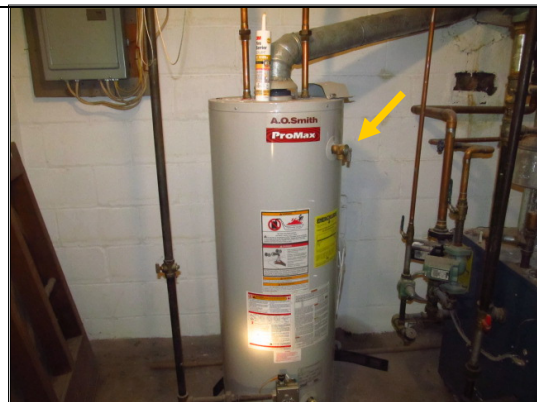
ITEMS	DESCRIPTION	COMMENTS / RECOMMENDATIONS
53 Water Heater	AO Smith Natural Gas	<p>(SHOWN) Extend relief valve drip tube to within six inches of the floor to prevent scalding or unnecessary property damage should valve discharge due to excessive temperature or pressure.</p> <p>The water heater was operational at time of inspection. Generally water heaters do not require replacement unless they leak. Periodic monitoring is advised. Replace unit upon the first sign of leakage. Flush tank periodically to eliminate build up of chemical deposits at base of this tank. Adjust water temperature (temperature above 120 degrees may scald).</p>

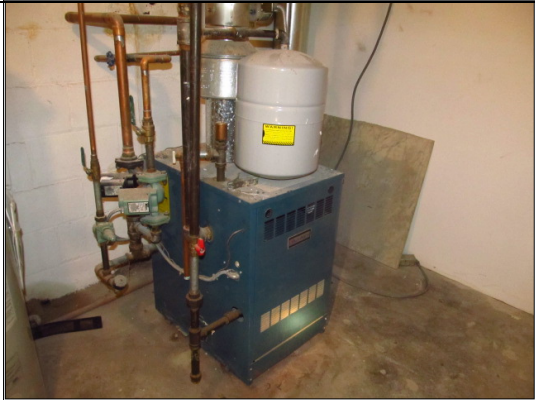
<p><i>Since this is an oil to gas conversion, the chimney should have been relined with stainless steel. A properly sized stainless liner will help exhaust gasses to escape chimney instead of cooling off and condensing which appears to be the case. If chimney is not allowing exhaust gasses to properly escape, there is a risk of carbon monoxide entering the dwelling. This should be checked by a chimney specialist. Also-obtain permit for oil to gas conversion-required by most municipalities-from seller.</i></p> <p>It is recommended to place all heating/cooling equipment under a service contract to receive regularly scheduled maintenance. Have the contract take effect a day or so before closing and arrange to have a heating/cooling technician present during a final walk-through to inspect and service equipment. Be sure to have an understanding as to which equipment and services will be covered under the contract.</p>

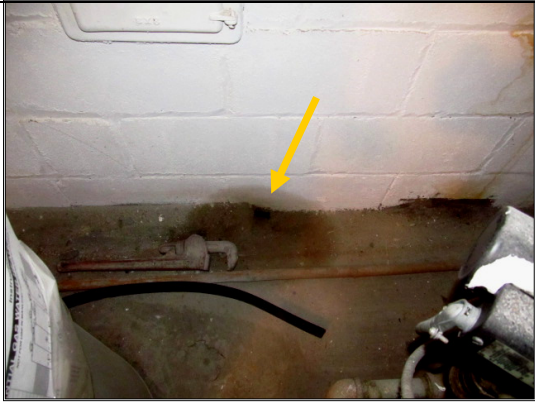
ITEMS	DESCRIPTION	COMMENTS / RECOMMENDATIONS
55 Burner	Natural Gas	<p>(SHOWN) Evidence of a buried oil tank was observed. Abandoned copper oil supply piping is present near boiler. This indicates the presence of an exterior buried oil tank or one that was removed from the basement. Buried oil tanks have the potential for leakage into soil, which can cause groundwater contamination. If soil contamination is present, the homeowner is liable for clean-up costs, which can be very expensive. Check with present homeowner for documentation regarding proper decommissioning of tank.</p> <p>Since gas is utilized as a fuel in structure, and this type of equipment/fuel presents certain hazards, it is advised to have equipment periodically serviced and checked for proper operation.</p>

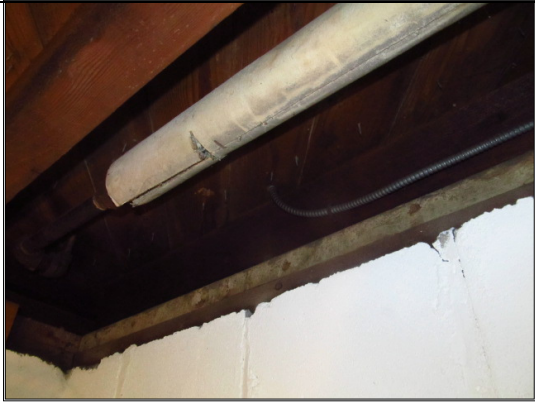
56 Humidifier	N/A	Not Applicable
57 Heat Pipes	Iron/Copper	<p>Existing heat pipe insulation may contain asbestos and sample testing by qualified laboratory is required to determine actual asbestos content (as visual determination of type of material and/or percentage content is not possible). The removal or encapsulation of this material by qualified asbestos company may be necessary depending on test results. If performed, this work is an expensive process.</p>

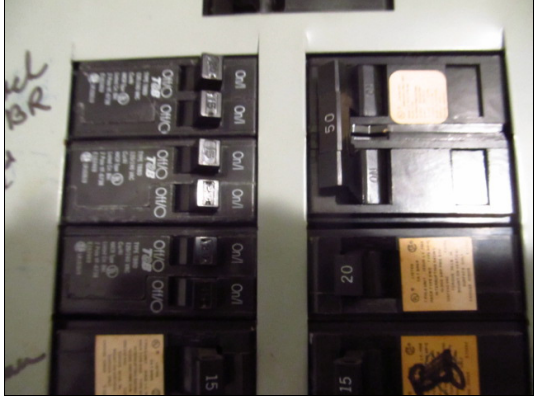
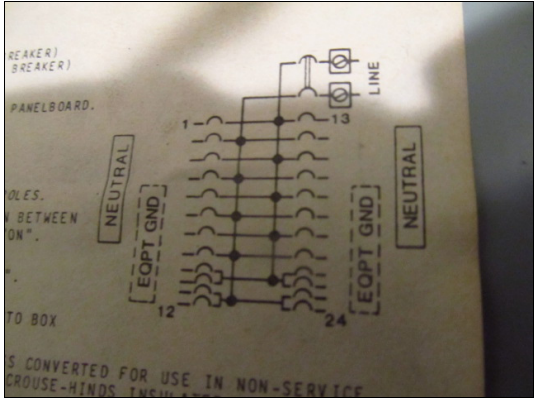
</div> <p>Photos 1 and 2 According to the manufactures schematic on the panel door, mini (or double) breakers have been installed in the wrong location. Often times this means the panel or breakers have been physically altered in order to fit.</p> <p>Any electrical equipment used in a manner other than specified by the manufacturer technically does not meet electrical codes and can be considered a fire/electrocution hazard.</p>

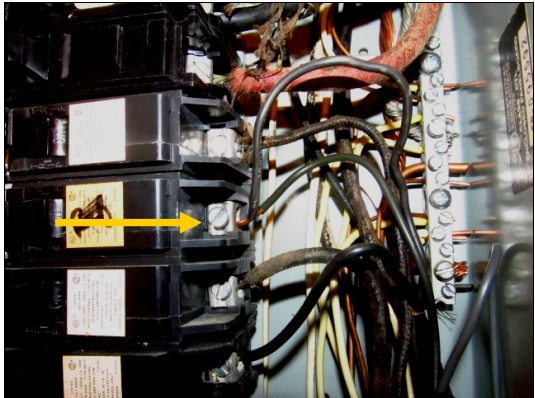
ITEMS	DESCRIPTION	COMMENTS / RECOMMENDATIONS
61 Electric Wiring	Copper/BX/Romex	<p>Third photo- Multiple wires are connected to a single lug on a circuit breaker where only one wire should be connected. When multiple wires are connected to a circuit breaker, the breaker cannot function properly. This may cause a fire, shock, or worse.</p> <p>Also-some of the older wire insulation is deteriorating. This should be checked by an electrician and replaced if needed.</p>
62 Central Air	N/A	Not Applicable

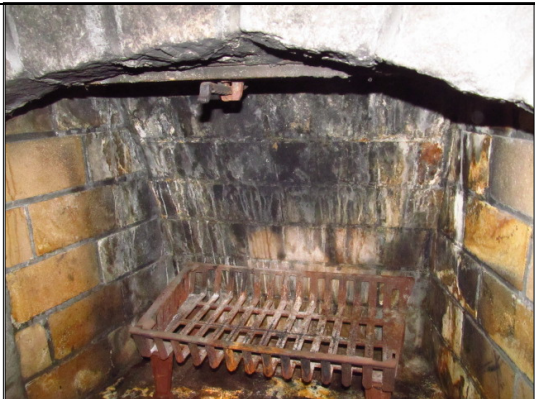
ITEMS	DESCRIPTION	COMMENTS / RECOMMENDATIONS
63. A/C Units	N/A	Not Applicable
63A. Fireplace	Wood Burning	<p>Evidence of water entry- interior masonry is worn, flue damper is rusted. Upon occupancy have fireplace cleaned/serviced prior to use, and on an annual basis there after. Have flue damper adjusted/repared for proper drafting.</p>
