Prepared for: Mr. and Mrs. First Time Home Buyer

Inspection Site: Somewhere in Nassau County, NY

Inspection Date: March xx, 2015

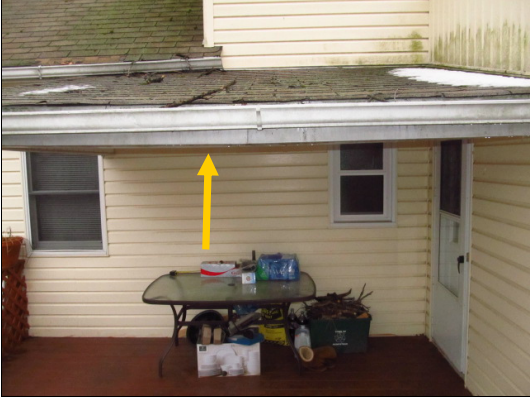
<p>The roof header is sagging as water has collected inside the aluminum capping causing header to rot. Header requires replacement.</p> <p>The support posts do not appear to have proper concrete footings. Future settlement may occur as a result.</p> <p>Improperly constructed decks/porches are subject to collapse, which can cause personal injury or worse. Obtain Certificate of Compliance or Building Permit for this structure to verify that it has been constructed according to acceptable building practices.</p>
